A SCANNING ELECTRON MICROSCOPE STUDY  
OF THE CORROSION OF SACRIFICIAL HULL  
ANODES UNDER SIMULATED SHIP SERVICE CONDITIONS

# THESIS

December 1976

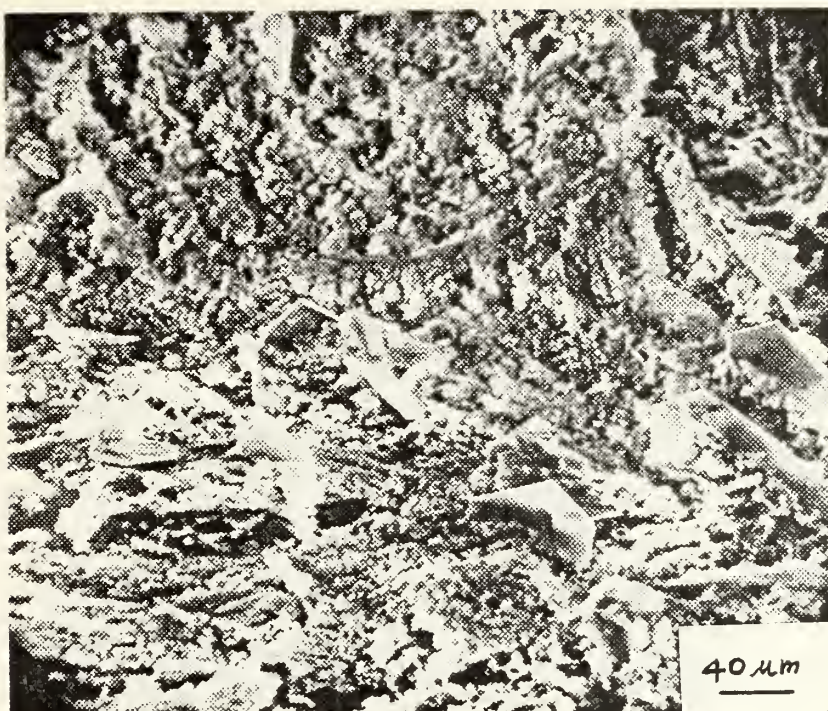
Zinc anode surface after 3 days static exposure, 130X (3DZ2)

Micrographs of a 3 day static exposure sample in which corrosion products rinsed off under a gentle stream of distilled water are shown in Figures 15, 16, 17, 18 and 19. Two distinct layers and morphologies were evident here. Figure 15 exhibits a thick intermediate corrosion product layer still adherent to the zinc anode surface. Figure 16 is a close-up view of the junction of the outer layer and the intermediate layer and also exhibits a portion of the zinc anode surface. It can be seen here that the intermediate layer has a dense mossy corrosion product makeup and appears to be on the order of 50  $\mu\text{m}$  thick. Also in evidence is the appearance that an outer layer of large platelets embedded in a compact layer of smaller platelets are the only platelet layers present. Figure 17 is a view of a 3 day exposure specimen showing platelet layers typical of those that have just been described. Figure 18 shows  $\text{ZnO}$  platelets embedded in the mossy intermediate product layer. These platelets were most probably left behind as the outer platelet layers rinsed away. Figure 19 is a micrograph of the zinc anode surface exhibiting crystallographic faceting along the hexagonal close packed basal planes. This type of faceting is typical of all zinc anode metal dissolution seen to date. Also evident in this micrograph are ribbon-like corrosion products, first discovered by Luebke [22], who hypothesized that these ribbon-like products usually surround initial dissolution sites on the zinc surface and are eventually grown over as corrosion product growth increases. Figure 18 substantiates the theory that the ribbon-like products remain as corrosion product film growth increases.

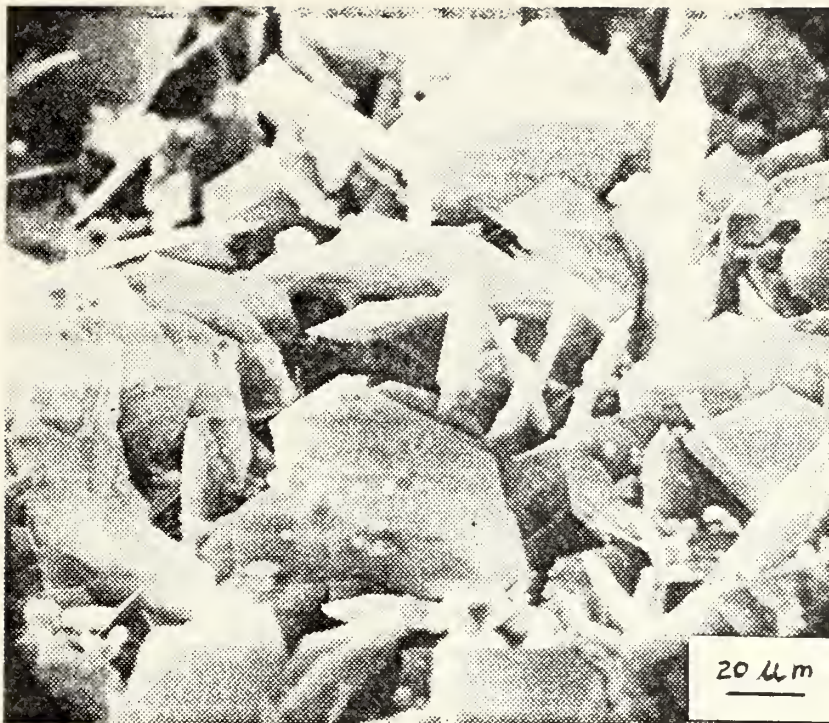
Figure 36

Zinc anode specimen 12HZ1 after 1 hour  
dynamic exposure at 150 rpm, 5 mA/in<sup>2</sup>,  
showing lack of reforming and redeposition,  
500X

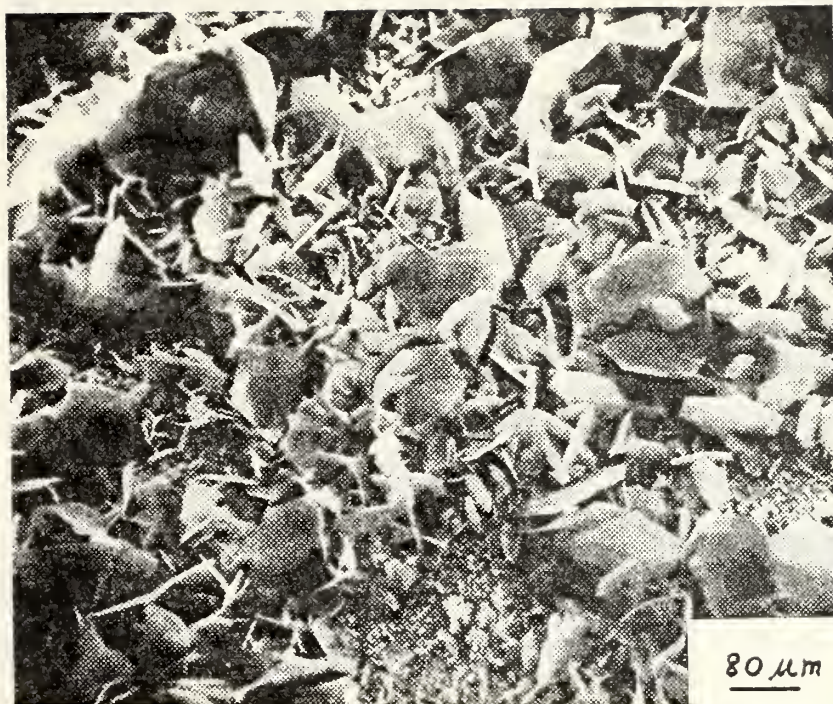
Figure 48

Zinc anode specimen after 2 day  
static exposure, 120X (2DZ1)

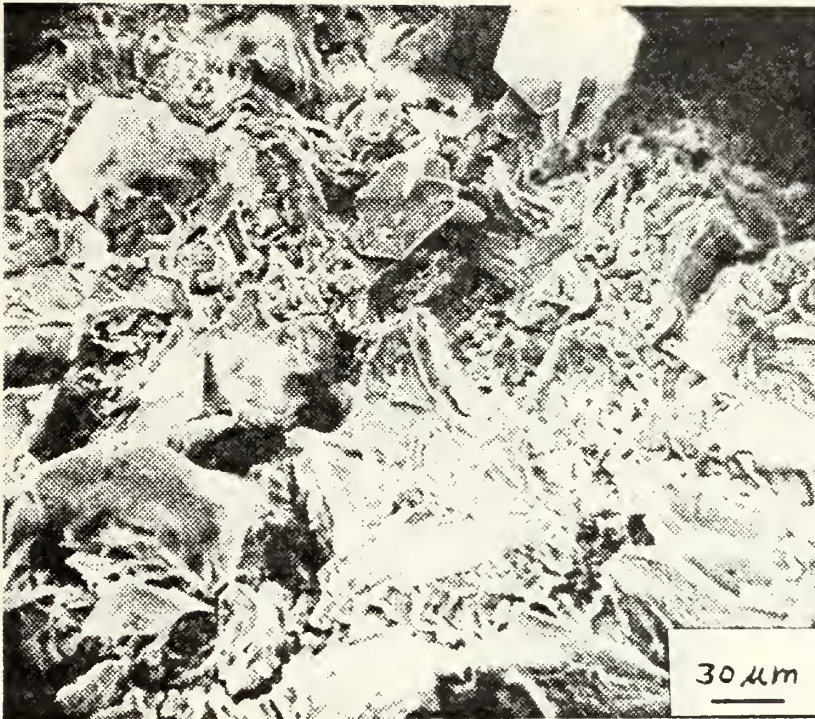
Figure 59

Zinc anode specimen 2DZ2 after 3 hour  
dynamic exposure at 50 rpm, 5 mA/in<sup>2</sup>,  
showing platelets reforming into crust  
formation, 325X

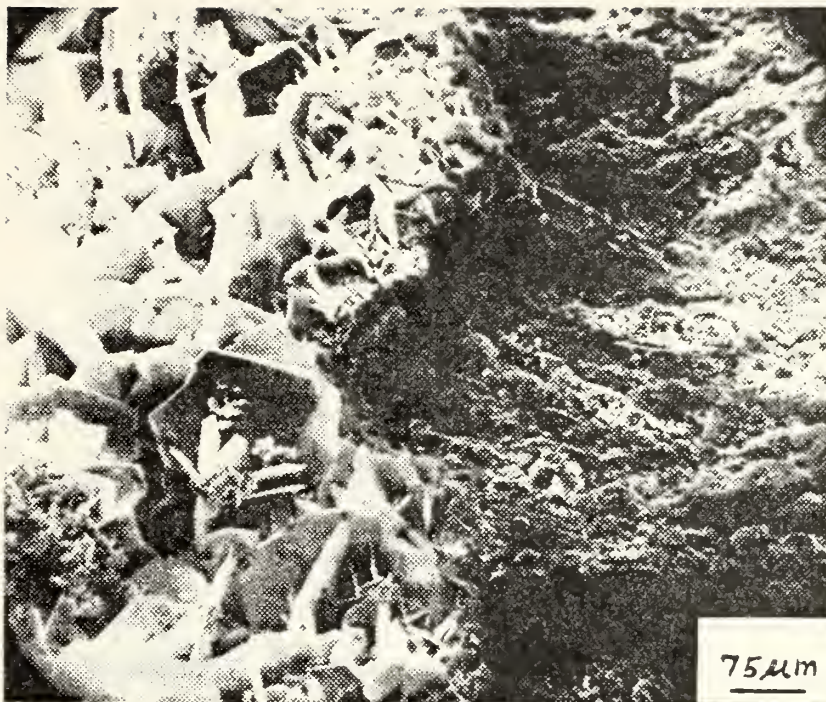
Another example of turbulent flow effects on corrosion products may be seen in Figure 60 which shows the results of platelet layer cracking and spalling of a dynamically exposed
